# THE INCOMPATIBILITY OF A STACK DESIGN TO THE EQUIPMENT IT SERVES

Gilles OUDIN

## ABSTRACT

*Described below is a chimney recently investigated.*

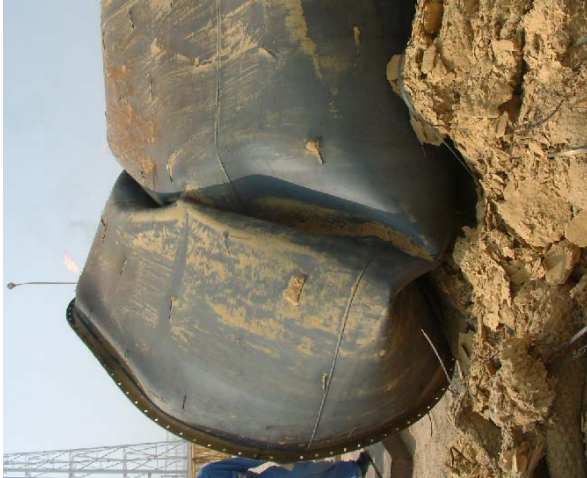
Photo 1 :view of one segment of the liner after partial dismantling

It was clear that the failure occurred due to the smoke temperature being too high. To find the reason for this accident an investigation concerning the whole process was necessary.

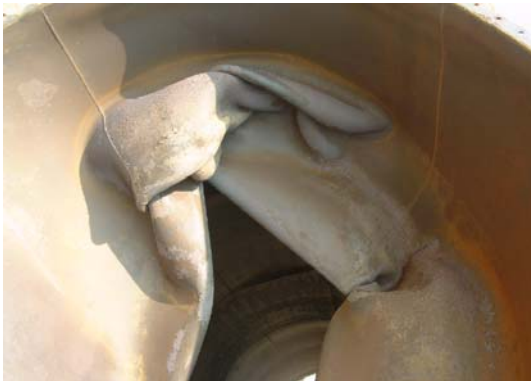
Photo 2 :detail of liner from outside

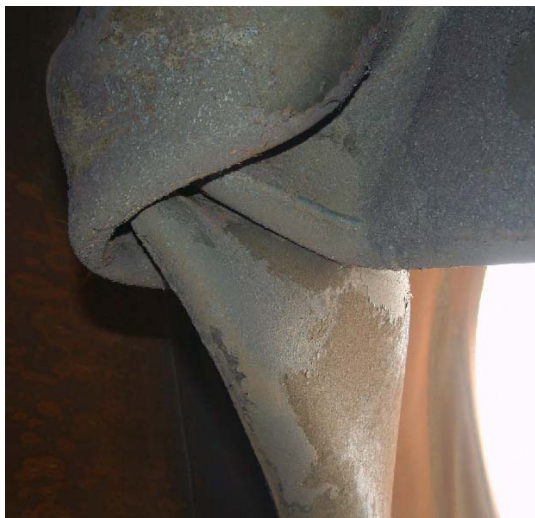
Photo 3 :detail of liner from inside.

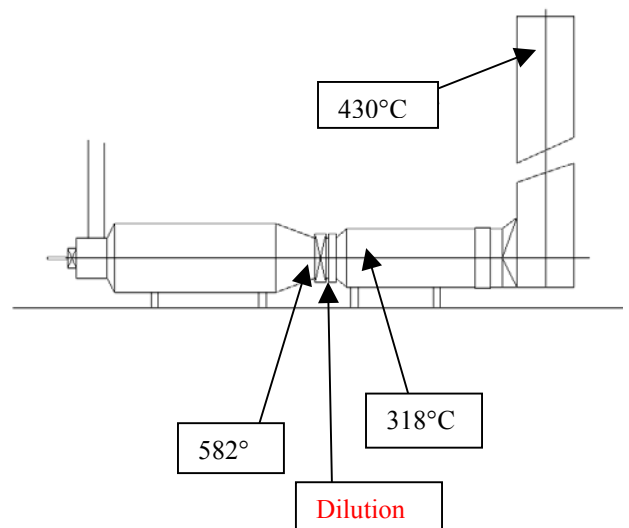
Figure4: measured temperature

It should be observed that the smoke temperature at the stack top is 112°C above the temperature at stack base.

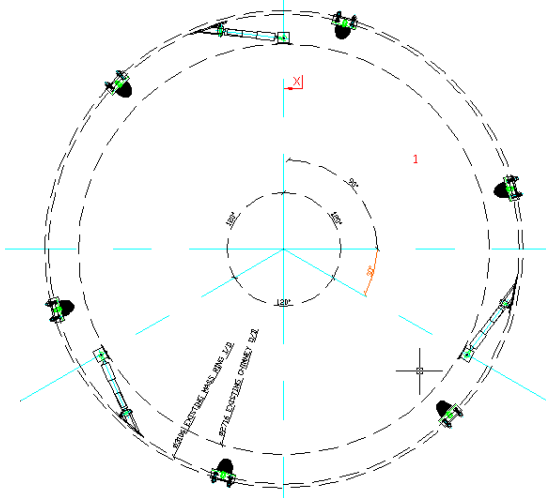
Figure 1 : plan view of the damper

So the number of cycles over a period of 10 years is huge due to the fact that the critical wind speed is small . The three dashpots of the damper were found completely broken which is not surprising because dashpots of any kind have a guarantee of 1 e6 cycles. Of course the life span is bigger than the guarantee and these dashpots could be used for perhaps 2 or 3 e6 cycles. Above this number of vibration cycles everything is dependent upon the maintenance period

The damper has to be replaced by another type of damper able to withstand a high number of cycles. An estimation of the number of vibration cycles has been made in order to have an idea of the filed of application of this damper system. This estimation has been made using the formula given in the DIN 4133 Code. The number of vibration cycles are

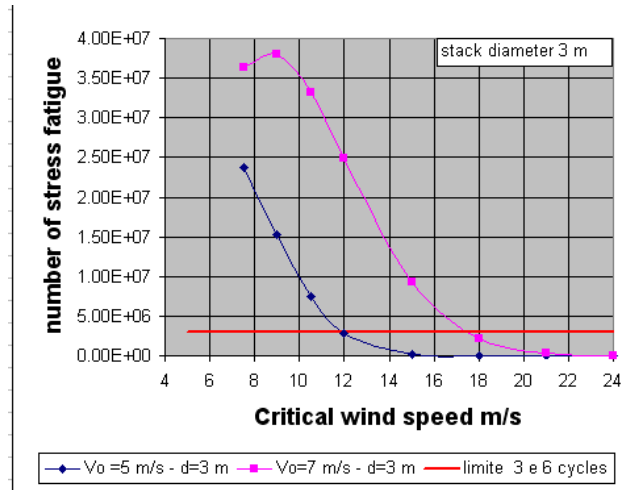
Figure7: number of vibration cycles versus critical wind speed for a 3 m diameter stack

In our case study, the stack diameter is about 3 m and critical wind speed is about 8 m/s; it is quite normal that the damper system has failed.
