# THE INCOMPATIBILITY OF A STACK DESIGN TO THE EQUIPMENT IT SERVES

Gilles OUDIN

## ABSTRACT

*Described below is a chimney recently investigated.*

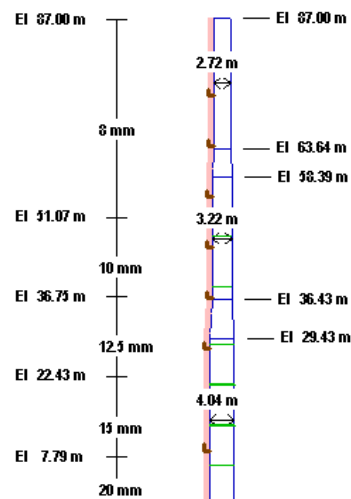
Figure 1 : stack view.

*The stack is equipped with a Tuned Mass Damper fitted with three hydraulic dampers.*

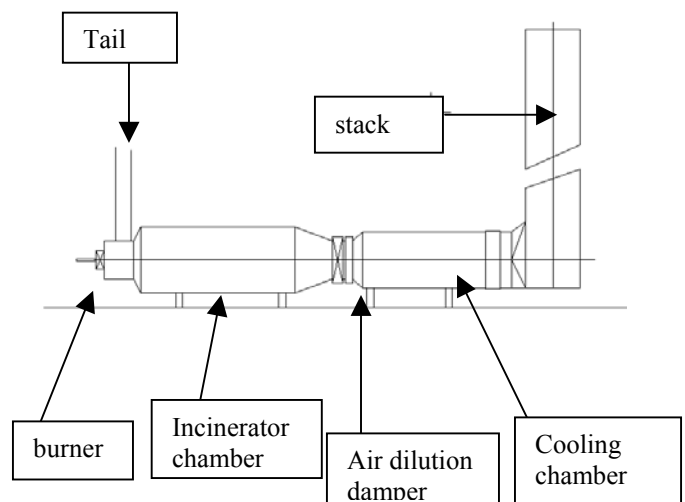
Figure 3: general view of the incinerator

As the incinerator was only burning tail gas the air dilution damper should have been closed but it wasn't. At first this was supposed to be on the safe side because it resulted in reducing the temperature in the stack liner.

The new operation conditions generated by opening the air damper results in in-sufficient natural draft at the burner; as a result, the combustion is not fulfilled in the combustion chamber. At the air dilution damper location , additional air was introduced by natural draft : a post combustion process was likely to occur in the stack

Opening the air dilution damper (which was supposed to be opened only in case of burning disulfide) to reduce the temperature in the stack because of inadequate material for the liner results in fact in post combustion with an extremely high temperature.

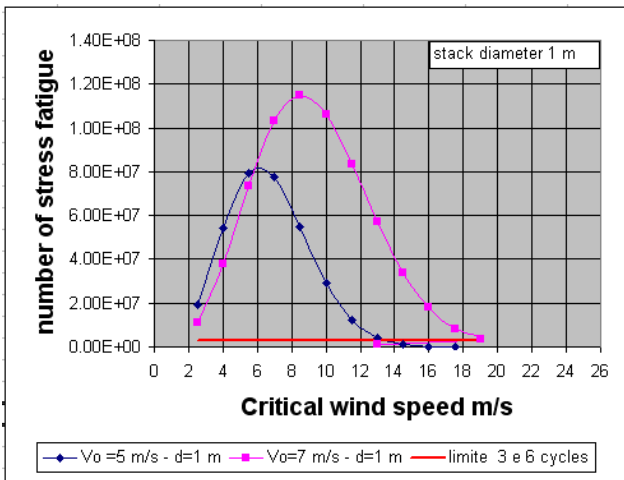
Figure5: number of vibration cycles versus critical wind speed for a 1 m diameter stack

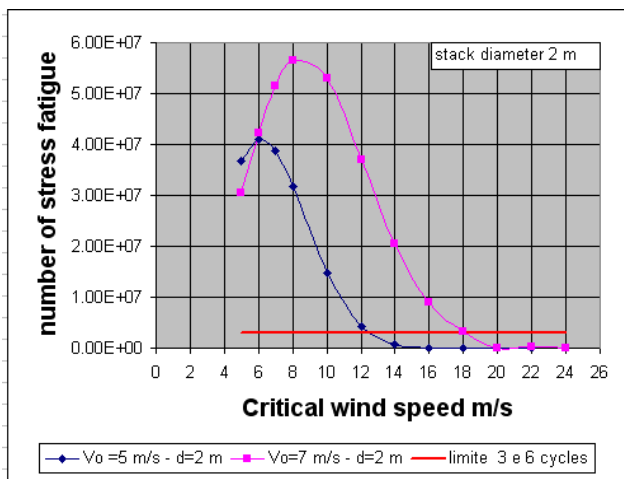
Figure6: number of vibration cycles versus critical wind speed for a 2 m diameter stack

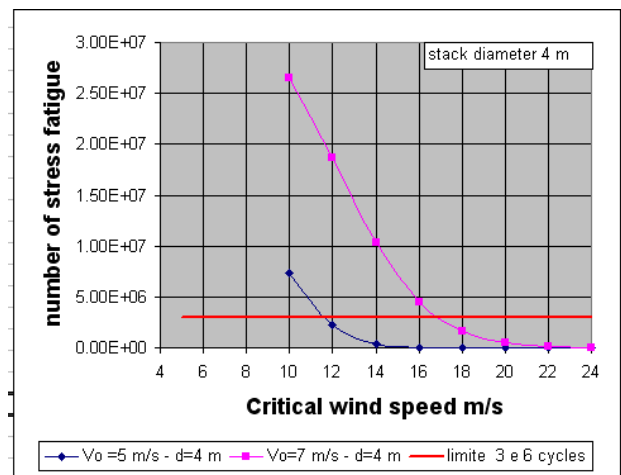
Figure8: number of vibration cycles versus critical wind speed for a 4 m diameter stack

In some extreme conditions a broken damper could also affect the liner fatigue resistance.

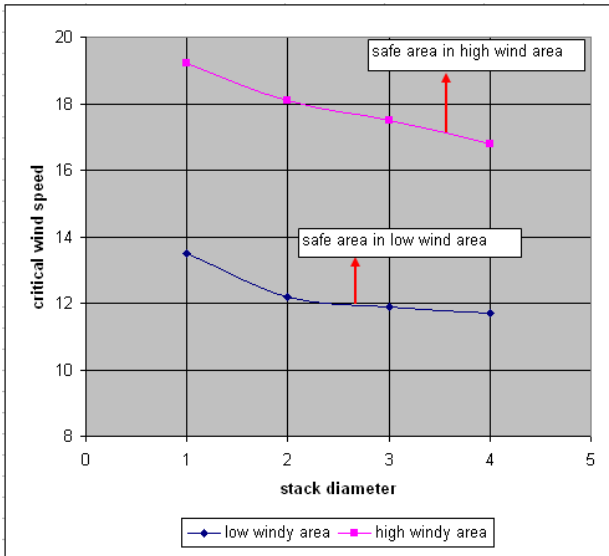
As a conclusion this type of damper is suitable for critical wind speeds above 12 m/s in low wind areas and above 17-18 m/s in windy areas.

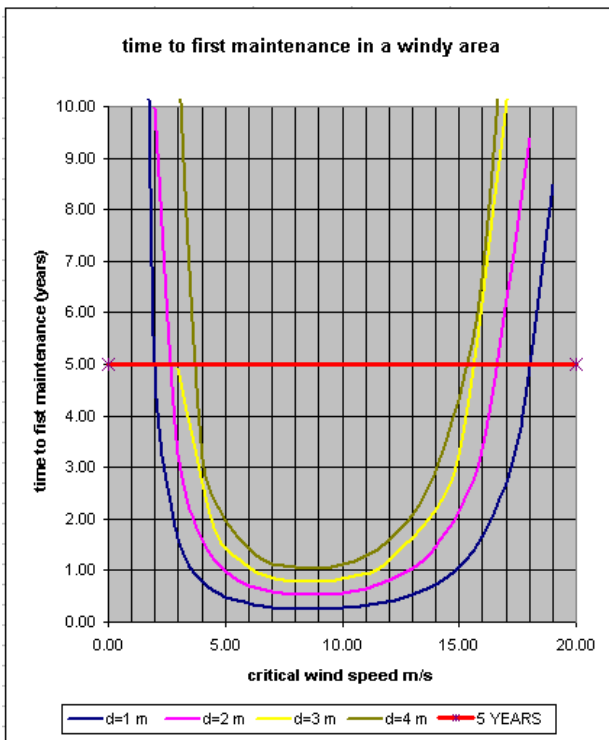
In a windy area and with a stack of 4 m diameter, the critical wind speed has to be above 15 m/s in

order to reduce the maintenance period to 5 years. If the critical wind speed is between 8 to 13 m/s then the maintenance period is smaller than 2 years. If the stack has a diameter of 1 m then the critical wind speed has to be above 18 m/s to keep this 5 years maintenance period.

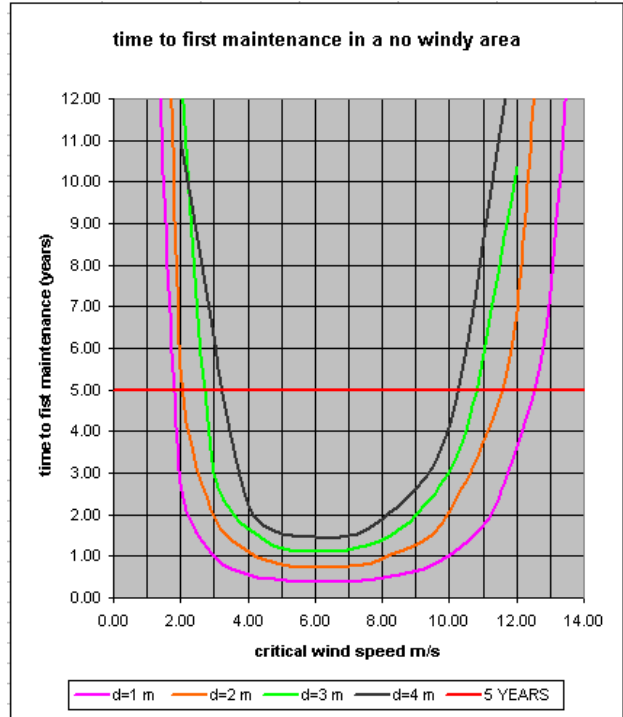
In a no windy area and with a stack of 1 m diameter, the critical wind speed has to be above 12 m/s in order to reduce the maintenance period to 5 years. If the critical wind speed is between 4 to 8 m/s then the maintenance period is smaller than 2 years

In our case the critical wind speed was 8 m/s and the stack diameter at top about 3 m. It is clear from the attached curves that the maintenance period was expected to be very small and it is not surprising to have found the dashpot broken. As an approximation, with TMD other damping devices than dashpots have to be taken into consideration when critical wind speed is less than 16 m/s in a windy area and 11 m/s in a no windy area.
